METALS HANDBOOK

VOL. 9
FRACTOGRAPHY AND ATLAS OF FRACTOGRAPHY

8th EDITION

Fractography and Atlas of Fractographs

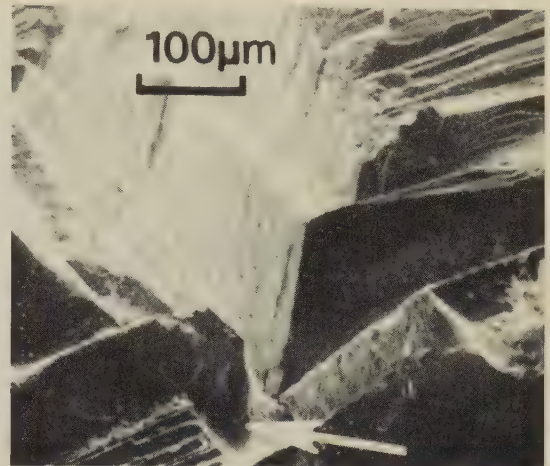
SEM fractograph

140×

3930 Surface of a cleavage fracture in a unidirectionally cast single crystal of nickel-base alloy MAR-M 200 that was heat treated* and then tested in ultrasonic fatigue at 20,000 cps at room temperature. The fatigue-crack origin was at a surface pore (arrow). See 3931, 3932 and 3933.

*Prior to fatigue testing, the crystals of MAR-M 200 in 3930 to 3933 were solution treated and aged. Solution treatment: 4 hr at 1232 C (2250 F), water quench; aging: 32 hr at 871 C (1600 F), air cool.

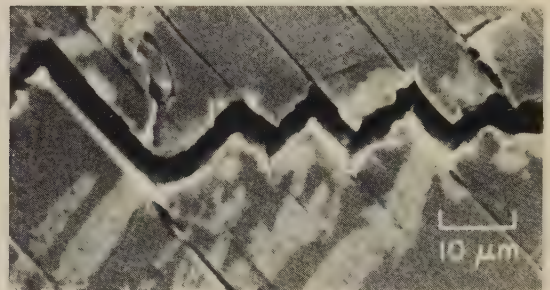
SEM micrograph

1000×

3931 An SEM micrograph of the [100]-oriented free surface of a single crystal of heat treated MAR-M 200 alloy* that was fatigue tested as described for 3930, showing crack propagation. The [001] longitudinal-displacement axis is vertical in this view; slip and crack propagation followed {111} planes.

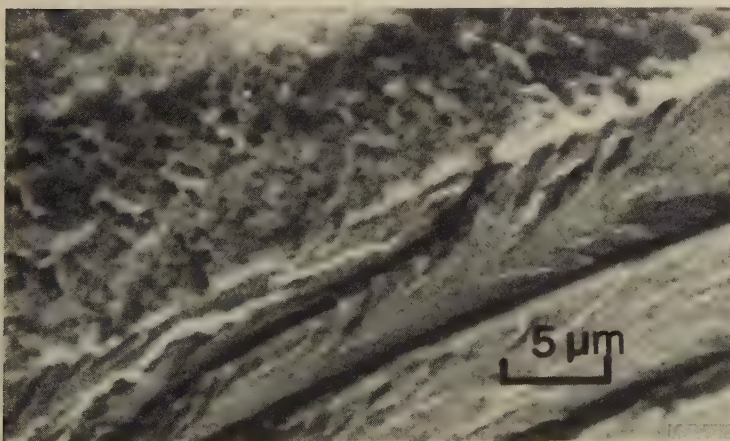
SEM fractograph

2800×

3932 A surface typical of the fracture near the site of fatigue-crack origin of the MAR-M 200 crystal* in 3930, showing sharply defined cleavage-fracture steps at lower right and, between the steps, systems of river patterns.

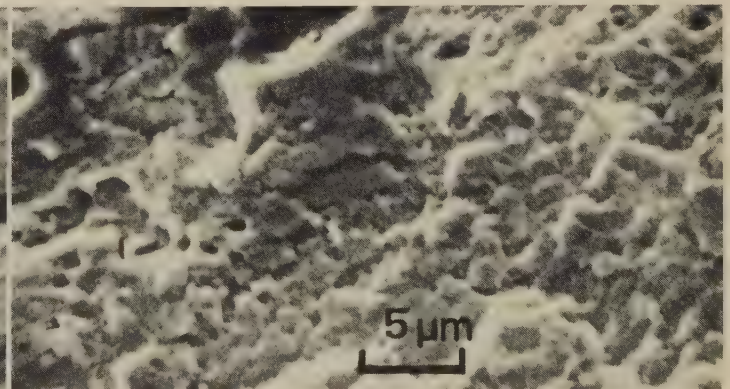
SEM fractograph

2700×

3933 High-magnification view of an area of an ultrasonic fatigue fracture in a crystal of MAR-M 200 heat treated* and tested same as for 3930, showing small, equiaxed dimples associated with late stages of crack propagation at total strain amplitudes of 0.0035 to 0.0055. (Contrast the appearance of the surface here with the blocklike cleavage facets in 3930, at 140×.)

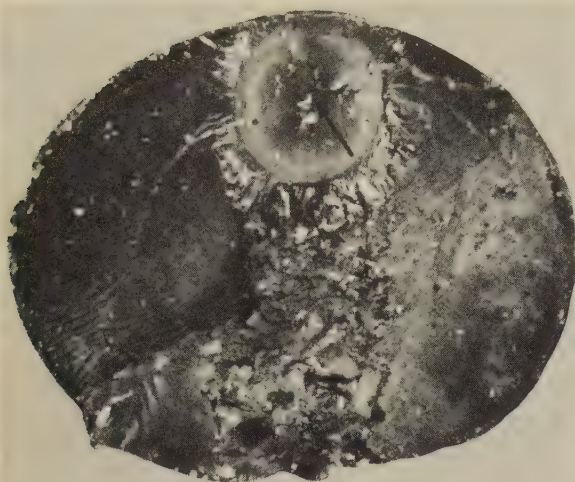
Light fractograph

16×

3934 Fatigue-fracture surface of a single crystal of MAR-M 200 nickel-base alloy tested in air at 927 C (1700 F) at a stress range of 515 MPa (75 ksi), and breaking at 950 kilocycles. Origin is at an internal pore (arrow near top). Compare 3935.

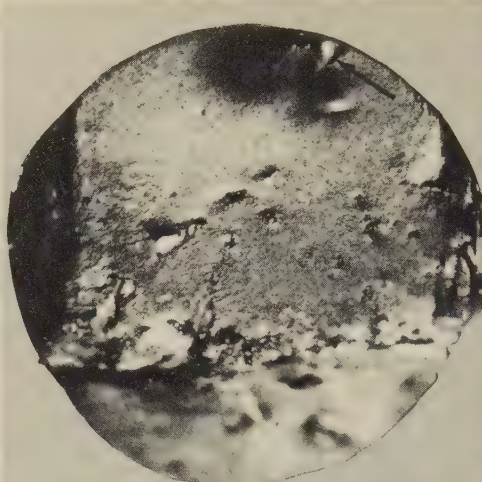
Light fractograph

25×

3935 Fatigue fracture in single crystal of MAR-M 200 tested in vacuum at 927 C (1700 F) at a stress range of 275 MPa (40 ksi). Fracture occurred at 1580 kilocycles. Origin is at a surface pore (arrow near top).

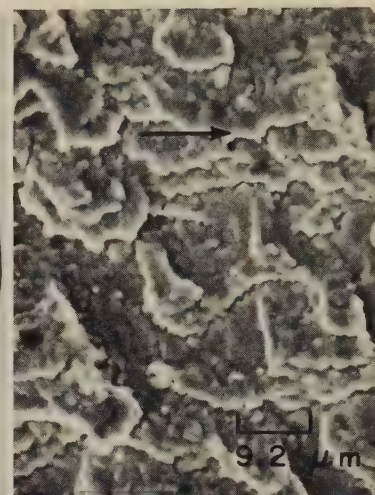
SEM fractograph

1080×

3936 MAR-M 200 fractured in low-stress fatigue at 927 C (1700 F) in air. Rough steps, with edges aligned nearly parallel to crack-growth direction (arrow), are oxide coated.

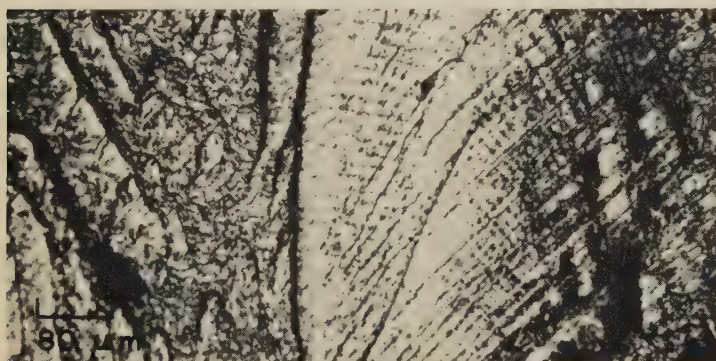
Light fractograph

125×

3937 Fatigue fracture in single crystal of MAR-M 200 tested in vacuum at 760 C (1400 F) at a stress range of 515 MPa (75 ksi). Fracture occurred at 2590 kilocycles. Unlike aluminum (see TEM fractograph 5149), this alloy shows clear fatigue striations when tested in vacuum as well as when tested in air. Here, crack propagation was from bottom to top. See fractograph 3938.

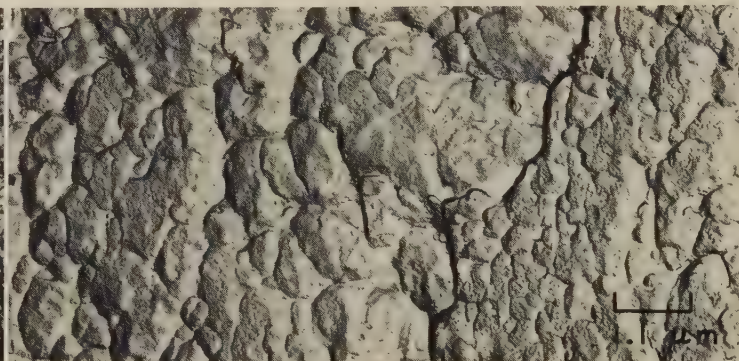
TEM fractograph (p-c replica)

9000×

3938 Replication of the surface of a fracture in a crystal of MAR-M 200 alloy that was fatigue tested in vacuum at 760 C (1400 F), showing equiaxed dimples. Visible are suggestions of vertical ledges roughly 4 μm apart; these do not seem to relate to fatigue striations such as those shown in fractograph 3937 (left), which have spacings of 10 μm or more.

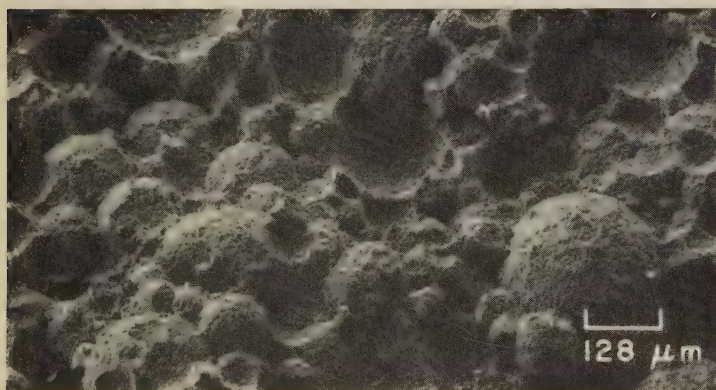
SEM fractograph

78×

3939 Tension-overload fracture in a compacted powder metallurgy specimen of IN-100 low-carbon nickel-base alloy, isostatically hot pressed at 1121 C (2050 F) for 2 hr at 172 MPa (25 ksi). The specimen was pulled at 1149 C (2100 F) at a strain rate of 0.0013 per second and broke in 14.3 sec, at a stress of 53.8 MPa (7.8 ksi). Particles are relatively undeformed. See 3940.

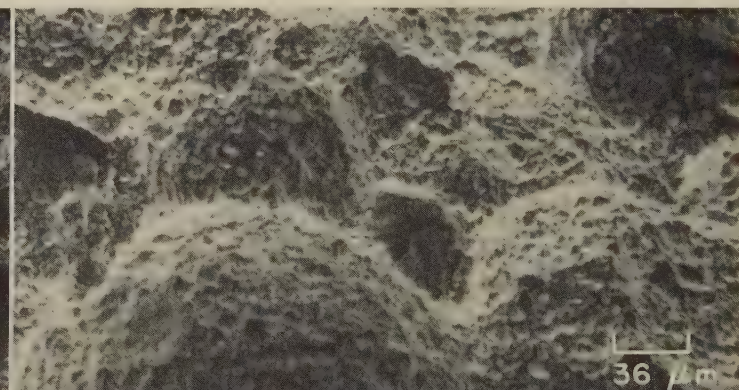
SEM fractograph

278×

3940 Higher-magnification view of the fracture in 3939 (left), showing clearly the dimple-like features of the surface of the powder metallurgy specimen. It should be noted that although the fracture followed the original interfaces between particles, there are no secondary cracks between the particles.

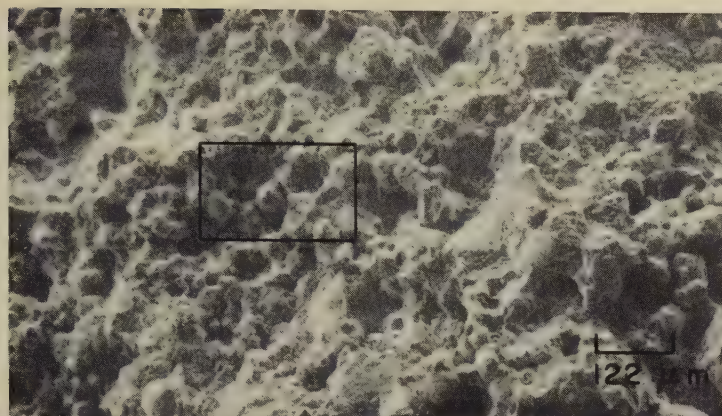
SEM fractograph

82×

3941 Fracture in a compacted powder metallurgy specimen of IN-100 low-carbon nickel-base powder isostatically pressed for 2 hr at 172 MPa (25 ksi) and 1232 C (2250 F). Specimen was broken in tension at 1149 C (2100 F). Strain rate, 0.0008 per sec; maximum stress, 97.2 MPa (14.1 ksi); test time, 24½ sec. Fracture is partly interparticle, partly transgranular. See also 3942.

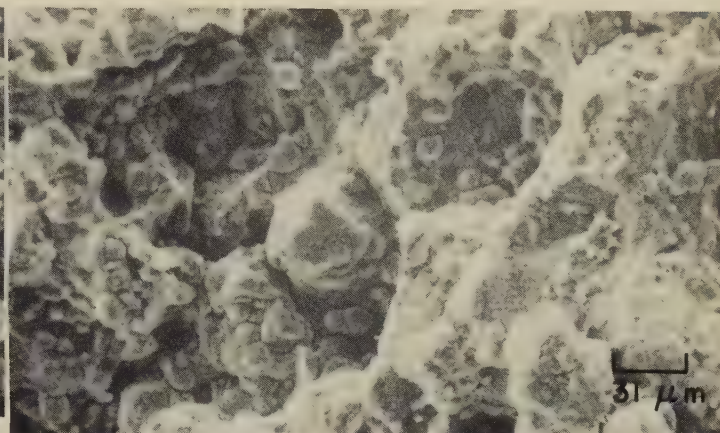
SEM fractograph

322×

3942 Enlarged view of area in rectangle in 3941. Here, fracture appears mostly, but not completely, interparticle. The small particles (about 1-μm diam) may be powder fines; however, this seems unlikely because fines should have been consolidated by the temperature and pressure used in producing the compact.

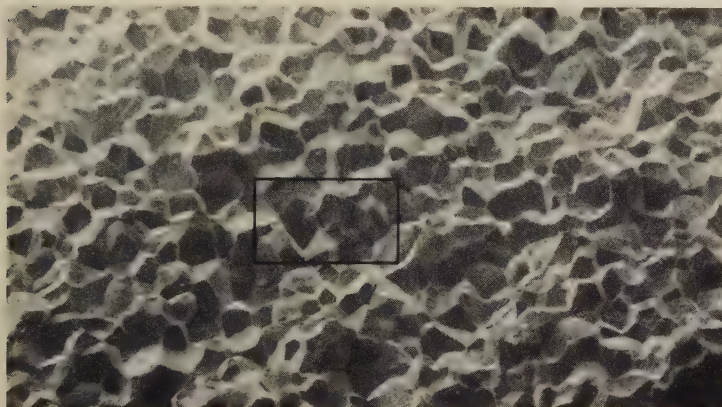
SEM fractograph

26×

3943 Fracture in a compacted powder metallurgy specimen of IN-100 low-carbon nickel-base powder processed under the same compacting conditions as described in 3941. Specimen was broken in tension at 1178 C (2152 F). Strain rate, 2.6 per sec; maximum stress, 128.2 MPa (18.6 ksi); test time, 0.005 sec. See also 3944.

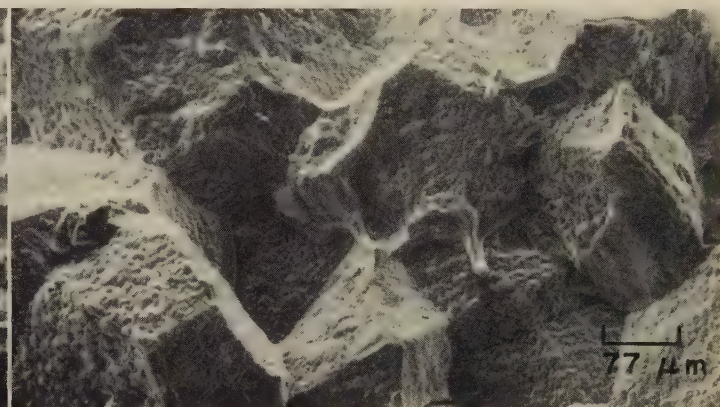
SEM fractograph

130×

3944 Higher-magnification view of the area in the rectangle in 3943. Unlike the specimen in 3941, the specimen here underwent recrystallization, either in hot pressing or during preheating at 1178 C (2152 F) before testing. The fracture is completely intergranular. Grain facets have features that may be dimples.

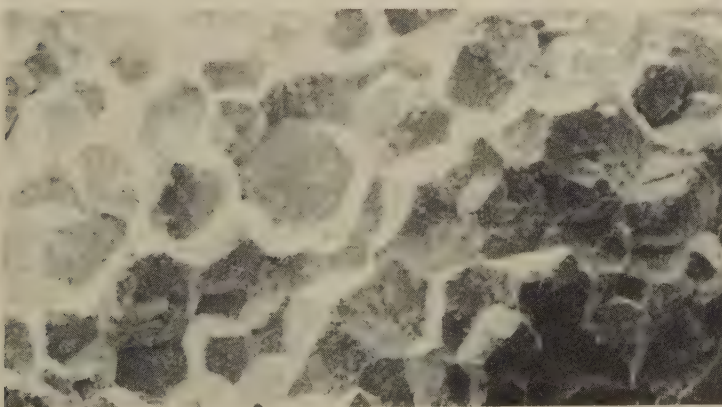
SEM fractograph

28×

3945 Fracture in a compacted powder metallurgy specimen of IN-100 low-carbon nickel-base powder for which the following sequence of temperatures was used, each for 1 hr, during isostatic hot pressing at 172 MPa (25 ksi): 1274 C (2325 F), 1243 C (2269 F), 1274 C (2325 F), 1243 C (2269 F). Specimen was broken in tension at 1149 C (2100 F), with a strain rate of 3.4 per sec and a maximum stress of 13.8 MPa (2.0 ksi). See also 3946 (right).

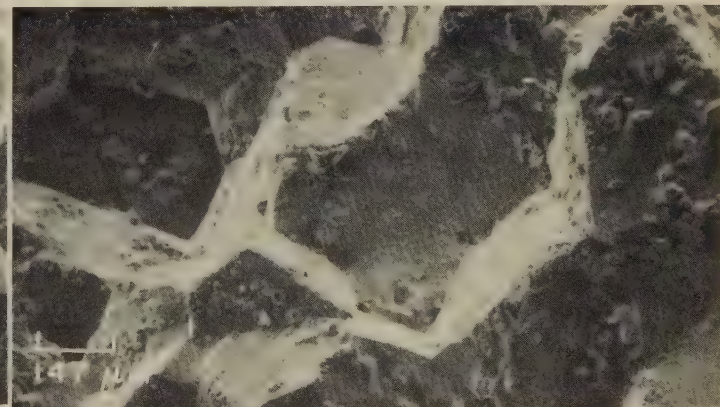
SEM fractograph

68×

3946 View of the fracture surface of the powder metallurgy specimen shown in fractograph 3945 (left), at a different location and at higher magnification. This specimen, like that in 3943, has undergone recrystallization, and the fracture is totally intergranular. The grain facets contain many small particles about 30 μm in diameter; it seems unlikely that they are powder fines.

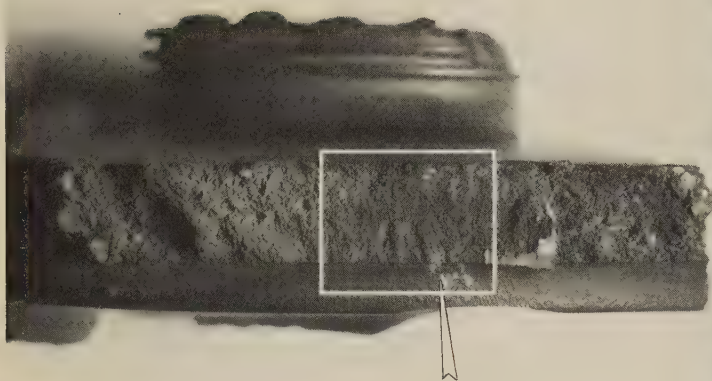
Light fractograph

2×

3947 Segment of a fractured second-stage gas-turbine wheel, cast from alloy 713C, that broke from fatigue in service. (About half of the disk portion of the wheel was never recovered.) The fracture origin (at arrow) was in a grinding-relief groove adjacent to the wheel-balancing pad. Additional circumferential cracks, not adjuncts of fracture, were found elsewhere in the grinding-relief groove. See 3948 for area in rectangle, enlarged.

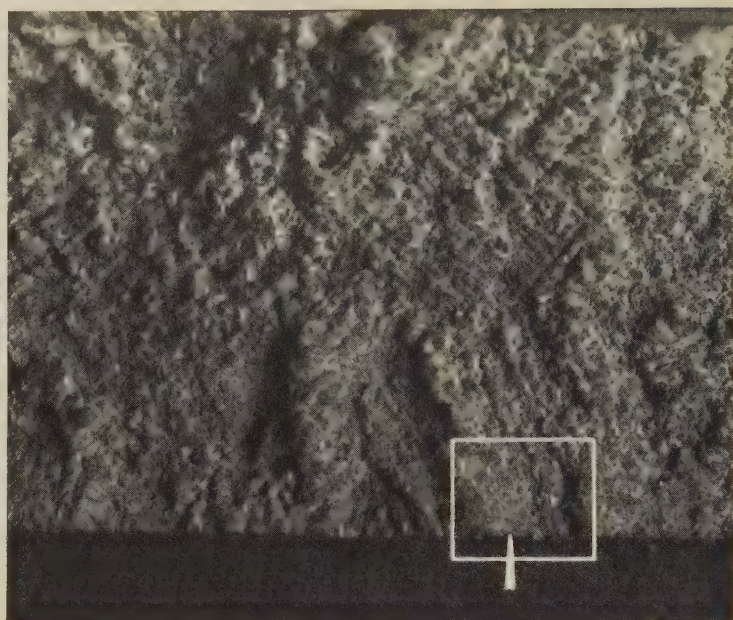
Light fractograph

10×

3948 Crack-origin region within the rectangle in 3947, at higher magnification. Arrow marks the probable location of the crack nucleus. The surface of the grinding-relief groove is below the fracture surface. Measurements of the radius at the bottom of the groove gave values that were about 70% of the average desired and about 87% of the minimum. The excessive sharpness of the radius may have been conducive to cracking. See 3949.

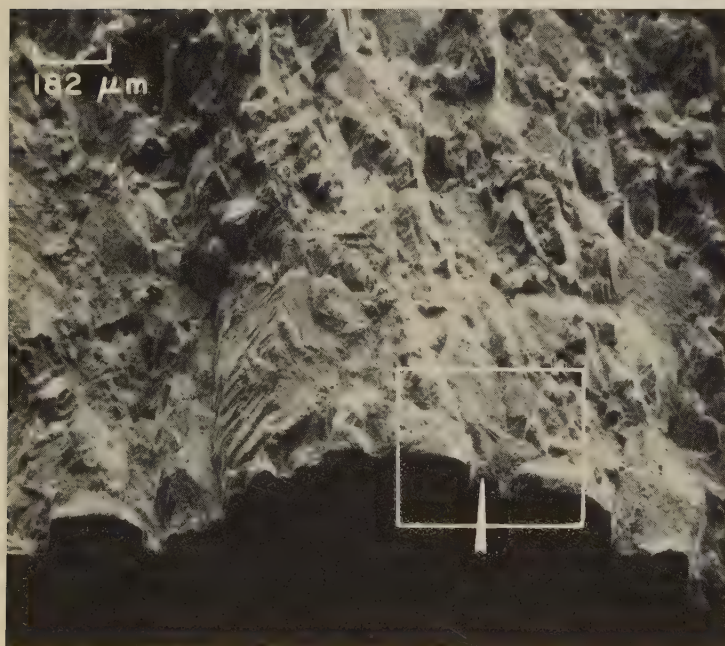
SEM fractograph

55×

3949 This SEM view was taken of the outlined area in 3948 after the fracture surface, which contained many white, gelatinous particles as received at the laboratory, was cleaned ultrasonically in 18% HCl solution for 1½ min and then washed in acetone and blown dry. The interface between the fracture and the grinding-relief groove was carefully examined in the origin area, and only one probable crack origin was discovered—that marked by the arrow. Area in rectangle is shown at higher magnification in 3950.

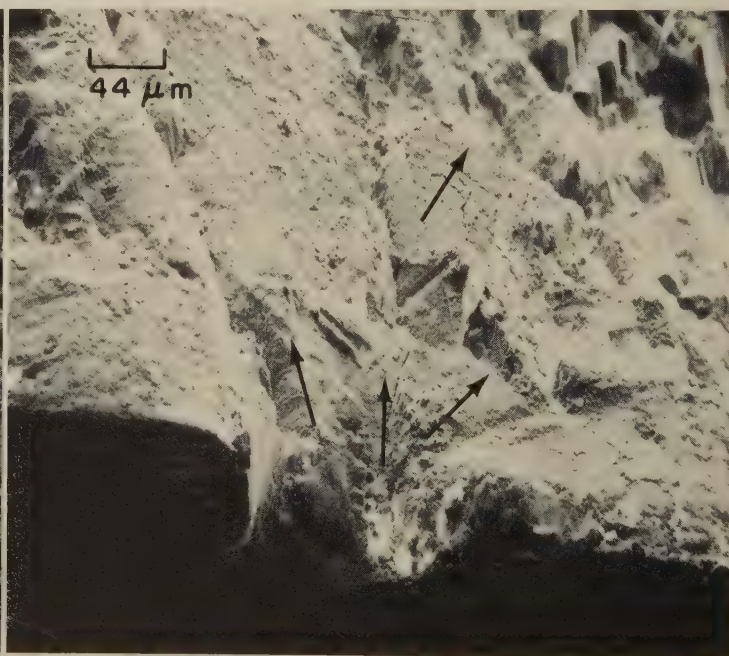
SEM fractograph

225×

3950 A view at higher magnification of the outlined area (containing the probable origin of fracture) in fractograph 3949. Numerous patches of fatigue striations are visible; the arrows indicate the directions of fatigue-crack propagation from what appears to be a surface defect within the grinding-relief groove. The fatigue facets were found to be transgranular, giving way, outside of the dark, crescent-shaped fatigue-crack area visible in macrograph 3947, to ductile dimples.

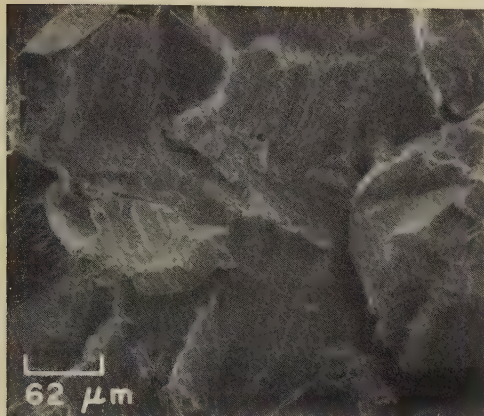
SEM fractograph

160×

3951 Fracture surface of a specimen of Duranickel, vacuum solution treated and quenched, aged 1 hr at 500 C (932 F) and cooled in air. The specimen, which was notched, precracked, and slow-bend fracture-toughness tested in hydrogen, broke by combined cleavage and intergranular fracture. See fractograph 3952 at right.

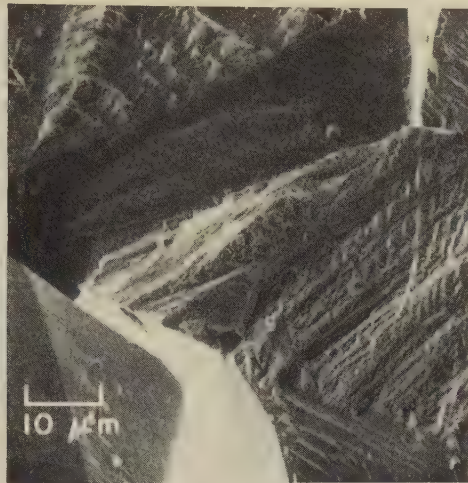
SEM fractograph

1000×

3952 A portion of the same fracture surface as that in 3951, but at higher magnification, showing facets that contain cleavage river patterns (bottom right) and pyramid-shaped tongues (top left).

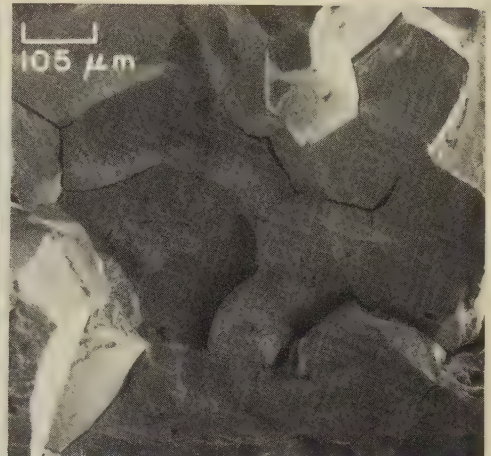
95×

SEM fractograph

3953 Fracture in Duranickel that, except for being aged 4 hr, was heat treated and tested same as 3951. Fracture here is more completely intergranular, with less cleavage, than 3951. Both fractures show secondary cracks. See also 3954.

3954 A view at higher magnification of the fracture in 3953, showing it to be also a nearly wholly intergranular fracture, with deep secondary cracks at the grain boundaries.

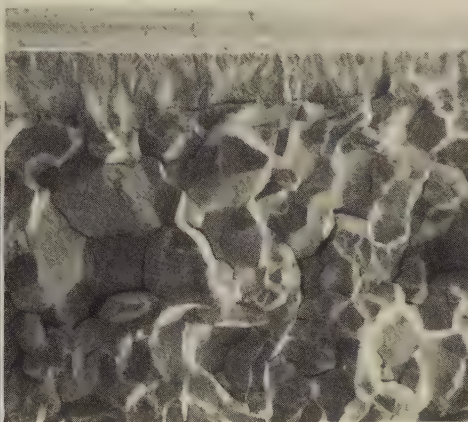
20×

SEM fractograph

3955 Fracture in Duranickel that, except for being aged 8 hr, was heat treated and tested same as 3951 and 3953. Notch and fatigue precrack are at top. An example of sustained-load intergranular fracture in hydrogen. See 3956 to 3958.

3956 A similar but larger view of the fracture in 3955, showing notch at top but no fatigue crack. Fine grains at notch were presumably cold worked in machining and recrystallized in aging.

3957 Same fracture as that shown in 3955 and 3956, but an interior area. One or two cleavage facets are seen. Most of the fracture is intergranular, with large secondary cracks.

3958 A highly magnified view of the fracture in 3955-3957. Striations visible here show crack advances under constant bending deflection in hydrogen; compare with the fatigue striations in 3959.

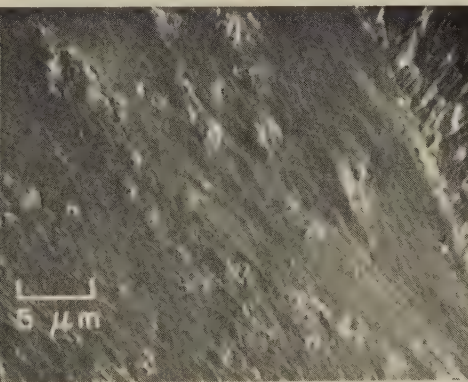
2000×

SEM fractograph

3959 High-magnification view of the fatigue precrack produced in air at base of notch in specimen in 3955. Compare fatigue striations here with crack-advance features in 3958. White marks at A's here are later fissures.

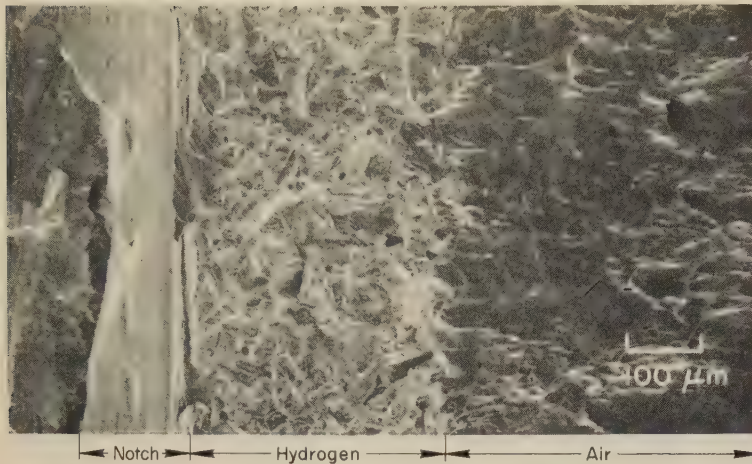
100×

SEM fractograph

3960 The fractograph at left shows the surface of a fracture in a bend-test specimen of Nickel 201 containing 0.02% C, 0.35% Mn, 0.01% S, 0.35% Si, 0.25% Cu, 0.4% Fe, remainder Ni. After the material had been annealed, a specimen 19 mm wide by 3.17 mm thick was prepared, a notch was machined in the side of the specimen, and a fatigue crack was produced in the root of the notch. The specimen was then loaded in three-point bending (77-mm support span) to give a fixed displacement rate of 0.0015 μm per sec. The test was performed at room temperature in a stainless steel chamber equipped for testing in vacuum, in hydrogen or in air. During the first portion of the test, the chamber was filled with hydrogen; partway through the test, the hydrogen was replaced with air. In this view, the notch is at the left, and just to the right of the root of the notch is a very shallow fatigue crack. The central region (light) is the portion of the fracture that was obtained in hydrogen, and the darker region at right is the portion that was subsequently produced in air. See 3961 to 3964 for higher-magnification views of the portions produced in hydrogen and in air, and of the transition between them.

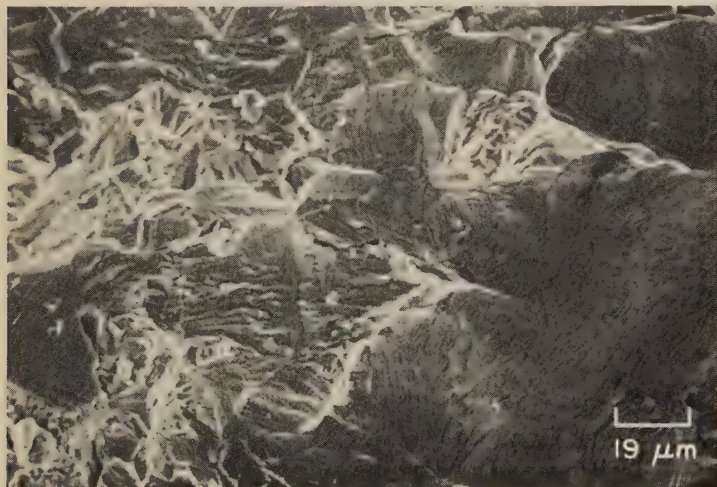
540×

SEM fractograph

3961 View of an area of the fracture surface in 3960 that shows the transition from fracture in hydrogen (left) to subsequent fracture in air (right). Much of the fracture produced in hydrogen shows transgranular cleavage. In the portion produced in air, flow occurred after the crack front had passed.

3963 View of the fracture surface in 3960, showing a region from the portion of the fracture that was produced in hydrogen. As in the left portion of 3961, the fracture here is mainly by transgranular cleavage. Scattered regions of intergranular separation were reported but are not visible here. See also 3964.

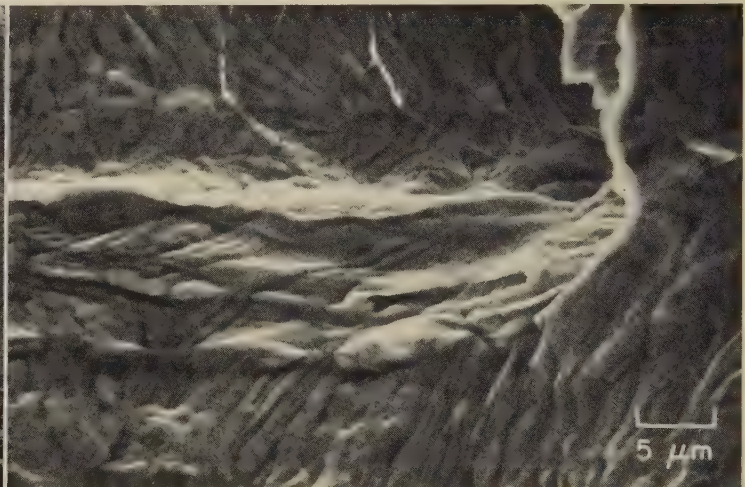
2000×

SEM fractograph

3962 View of the fracture surface in 3960, showing a region from the portion of the fracture that was produced in air. Visible are suggestions of dimples, but these features have been largely obscured by the effects of the secondary flow that occurred in this very ductile metal following passage of the crack front.

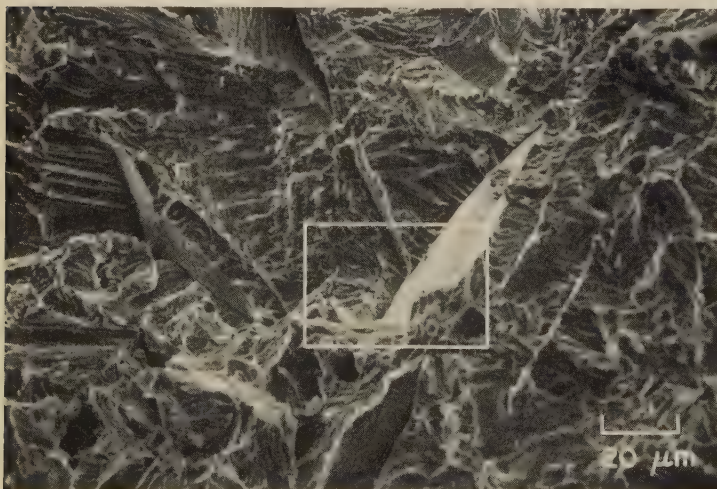
500×

SEM fractograph

3964 Higher-magnification view of the area outlined by the rectangle in fractograph 3963 (left), showing the ledge-like character of the cleavage facets. In contrast, a suggestion of dimpled rupture is visible at bottom right. Note the small tongues on the bright facet at right.

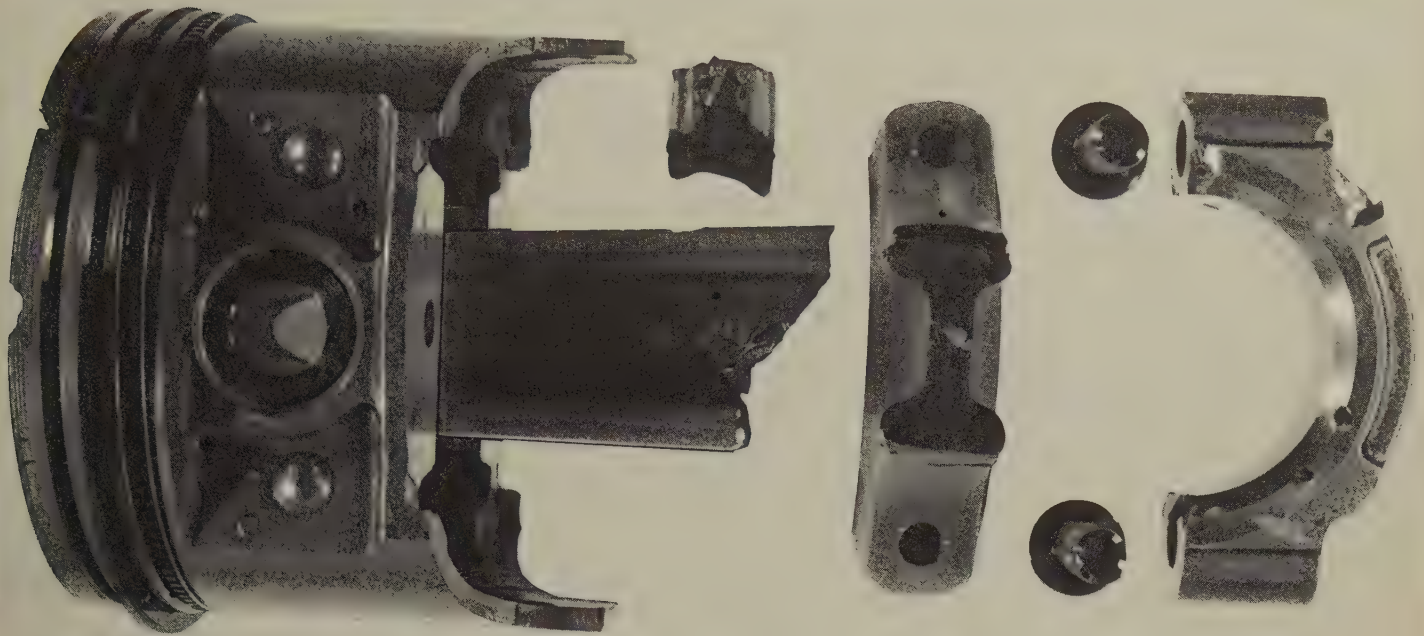
About $\frac{3}{4} \times$

Photograph

3965 Components of an experimental automotive connecting rod that fractured by overload during testing. (Shown also is the piston used in the test.) The rod was cast of aluminum alloy 333. Note that the shaft of the connecting rod suffered a compound fracture; the portion closest to the cap has a relatively straight, transverse fracture surface, and the portion connected to the piston shows a partially diagonal fracture, with the segment that broke away shown above the shaft. It is not known whether both fractures occurred in the shaft at the moment of initial fracture or whether the segment broke away later due to impact within the cylinder before the engine was shut off. The fracture surface visible here bears no features that in any way suggest a fatigue fracture. The 4340 steel bolts (left of cap at far right) also broke; for details of the bolt fractures, see 3678 to 3685. See also 3966 and 3967.

3966 Fracture surface of the portion of the aluminum alloy 333 connecting rod in 3965 that was still attached to the piston after the test. It appears that each flange contains a chevron pattern, which suggests that there were two crack origins. This supports the theory that two successive fractures occurred in the rod. The mechanical damage in the right fracture surface indicates that the right origin probably led to the initial rupture. There are no indications of the beach marks that are characteristic of fatigue fractures. See also fractograph 3967 (right).

3967 High-magnification view of one of the fracture surfaces of the fractured connecting rod shown in 3965. It is evident that fracture was by dimpled rupture, which indicates that the fracture was caused by sudden overload. As in the views at about $\frac{3}{4} \times$ in 3965 and at 2× in 3966, no indications of fatigue are visible here. The fracture appears quite "clean" with very little evidence of nonmetallic inclusions.

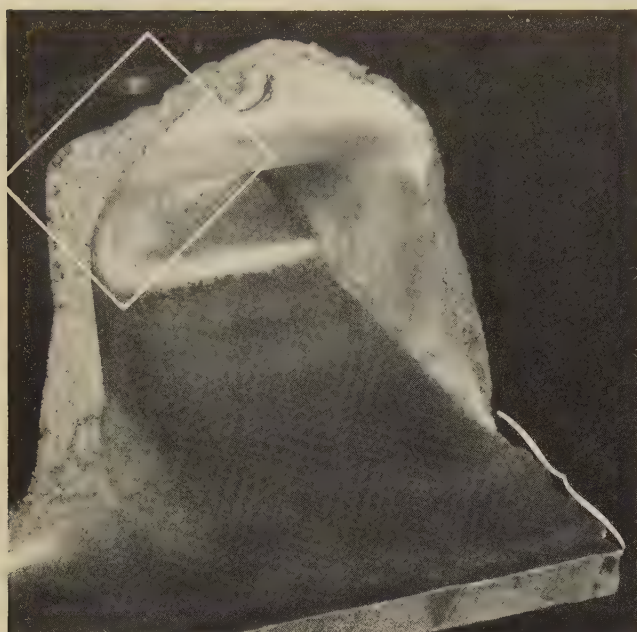
Actual size

Photograph

3968 A portion of a fractured carrier tray sand cast of an aluminum alloy intended to be 356-T6. Chemical analysis revealed that the copper and zinc contents were of an order of magnitude above the specified limits. The silicon content was approximately as dictated by the specification. The hardness measured 82 Bhn — appreciably above the 70 Bhn expected. Tensile strength was 179 to 193 MPa (26 to 28 ksi) — slightly below the specified minimum of 207 MPa (30 ksi). See 3969 for area in rectangle, and 3970 for bracketed area, at a magnification of three diameters.

3969 Fracture surface of the rectangle-outlined shoulder of the sand cast carrier tray in 3968. The appearance of this surface suggests that fracture occurred in a brittle manner. The two arrows at "a" indicate two large gas cavities. The arrows at "b", "c" and "d" identify sites that were examined with a scanning electron microscope. (SEM fractographs of these sites are shown in 3971, below, and in 3972 to 3975, on the opposite page.) Note the absence of shear lips on the edges of this fracture surface, indicating a general lack of ductility.

3970 This fracture surface is from the bracketed edge of the sand cast carrier tray in 3968. Like the surface shown in 3969, the one here also exhibits the characteristics of brittle fracture, there being no sign of a shear lip at any of the edges. Again, there is evidence of porosity; the arrows point to quite large gas cavities. The cavities could have been caused by a reaction between the liquid metal and organic binders in the sand mold, or could have resulted from entrapped air being carried into the mold by undue turbulence in pouring the casting.

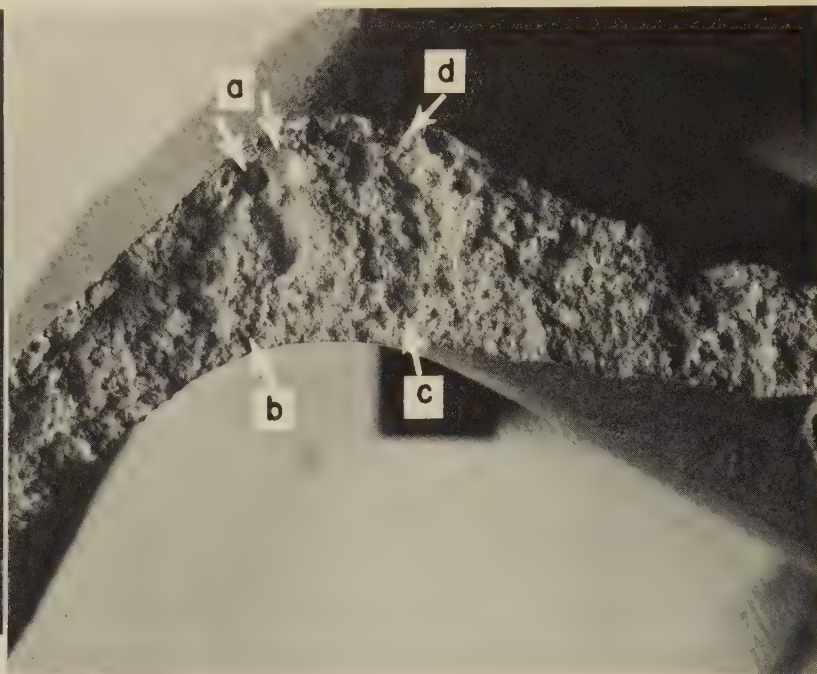
3×

Light fractograph

3971 Area at the lower edge of the fracture in 3969, as indicated there by arrow at "b". Two regions of shrinkage porosity, at upper right and lower left, contain dendrite lobes, which existed as "free surfaces" within the cavities after the available liquid metal solidified. This behavior can be caused by an excessively high pouring temperature (which exaggerates total contraction in freezing) or by failure to provide proper risers.

3972 Area at arrow "c" near the lower edge of the fracture in 3969 (opposite page). At the low magnification here, it is not possible to identify details of the mechanisms of fracture. This view, however, does show many cavities, some of them resembling dark slits, indicating quite generally distributed shrinkage porosity. Smeared region at upper left indicates mechanical damage — probably in handling of the carrier tray after fracture occurred. See also fractograph 3973 (at right).

3974 This SEM view was taken in the area marked by arrow "d" in the fracture shown in 3969. This area exhibits a distribution of very small cavities, believed to be gas pockets, that are of a much different order of magnitude from those indicated by arrows at "a" in 3969. The latter were about 1.5 mm in diameter, whereas the cavities here are about 25 μm across. At bottom and left, a small portion of the exterior surface of the casting is visible. See also fractograph 3975, at right, for a view of this same fracture surface area at higher magnification.

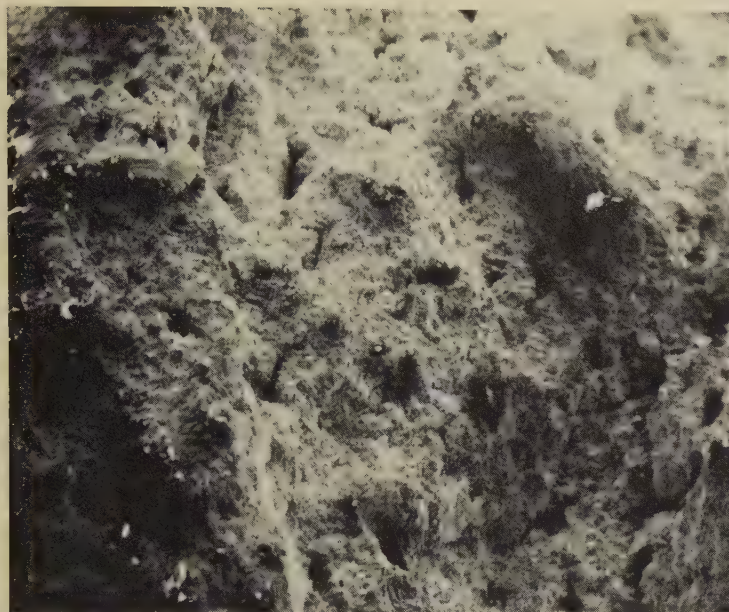
18×

SEM fractograph

3973 A portion of the same fracture area as that in 3972 (area at arrow "c" in 3969), as seen at higher magnification. This view shows a complicated array of facets separated in many instances by indications of isolated dimples. The degree of flow in microvoid coalescence, however, did not contribute materially to ductility, and over-all fracture was brittle in nature. This region does not contain any of the shrinkage porosity seen elsewhere in this fracture but may contain nonmetallic inclusions.

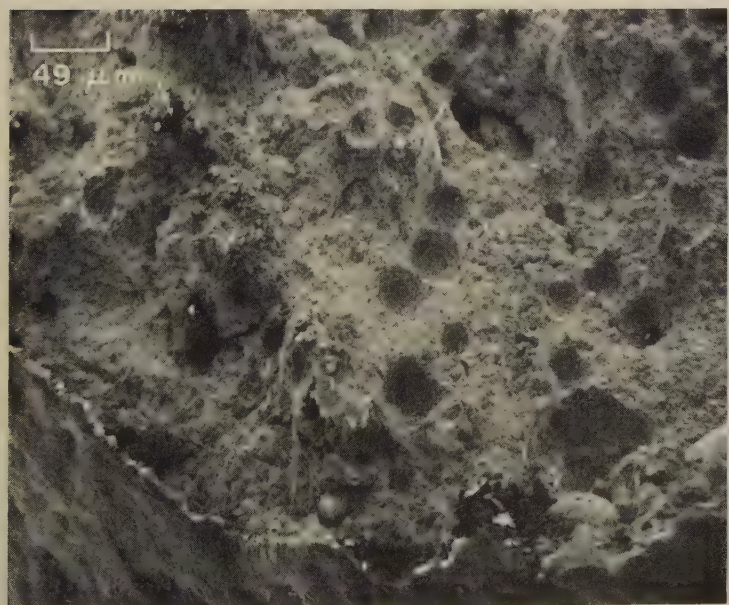
205×

SEM fractograph

3975 Enlarged view of a part of the fracture surface area in 3974. Some features vaguely resemble fatigue striations, but it is doubtful that they were caused by fatigue inasmuch as they do not seem to have been formed in an orderly sequence (and there are no beach marks in fractographs 3969 and 3970). Instead, the surface is very tumbled, with no suggestion of fatigue patches, and many regions bear whiskerlike features resembling some form of cleavage step. Lacking a significant amount of dimples, this surface can be rated as a brittle fracture.

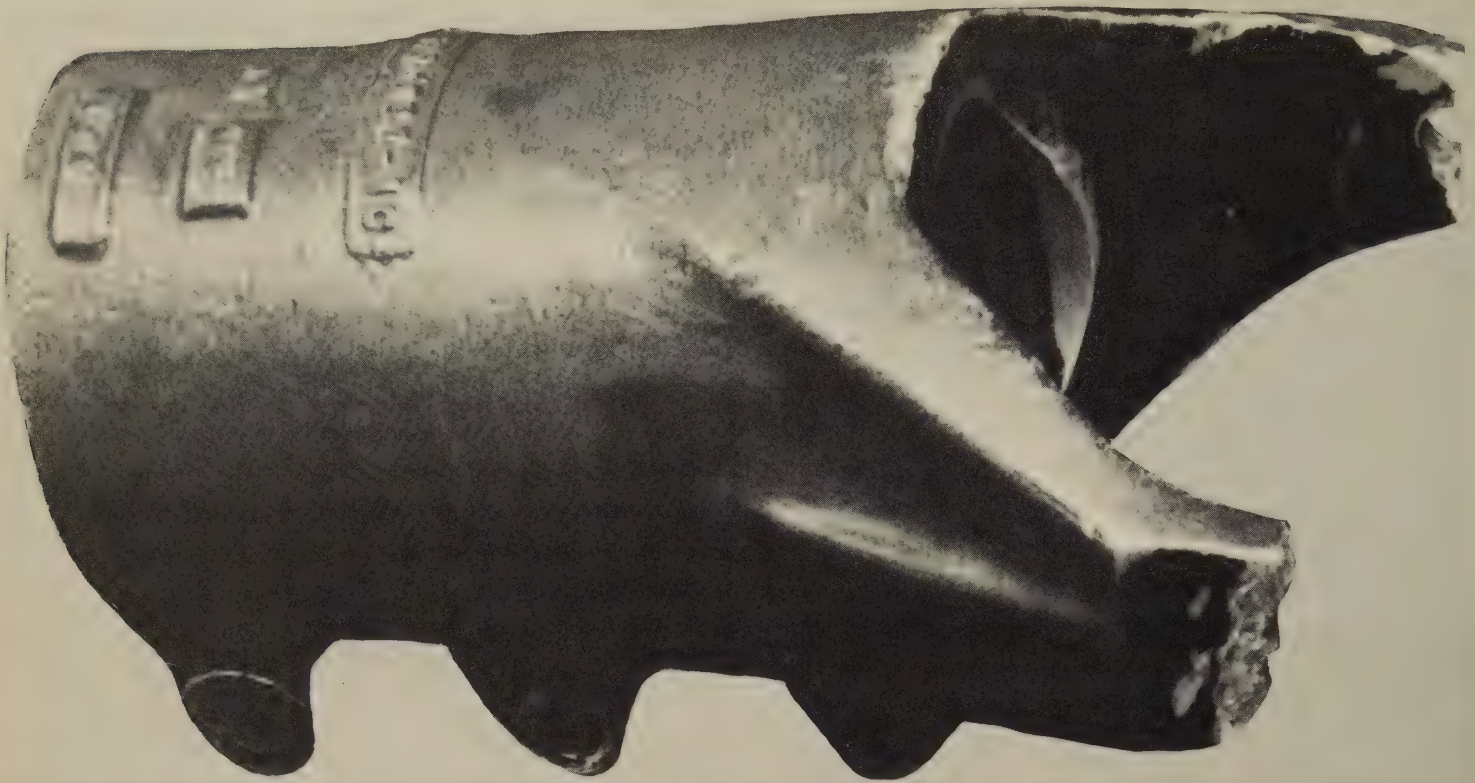
Actual size

Photograph

3976 A broken extension-housing yoke, part of a helicopter tail-rotor drive assembly, that fractured by fatigue in service. The fracture occurred through the left and right lugs at the points of attachment to the tail boom. The yoke was cast from aluminum alloy 356 and heat treated to the T6 temper. Chemical analysis showed that the composition of the yoke conformed to specifications except for silicon, which was 0.05% below the required minimum. Hardness measurements ranged from Rockwell B 48 to 52 (or about 81 to 85 Bhn), which was above the required minimum. Details of the fractures are shown in 3977 to 3984 (below, and on the opposite page).

3977, 3978 Both sides of each of the two lugs that were broken from the extension-housing yoke shown in 3976, above. The inboard sides of the lugs are shown in 3977 (left); the outboard sides, in 3978 (right). Mechanical damage and loss of paint are evident. See 3979, at right, and 3980, on facing page.

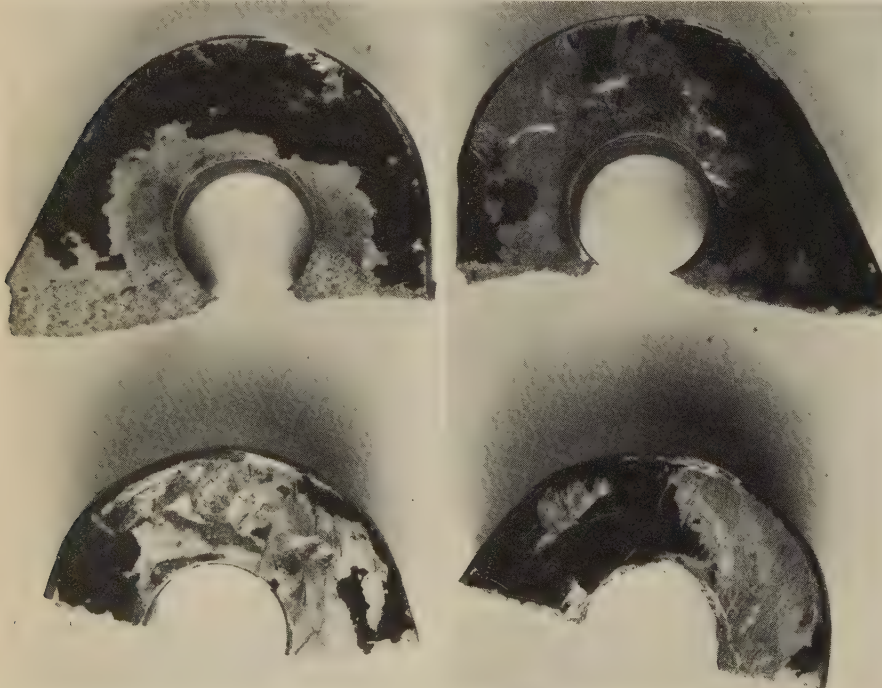
2×

Photograph

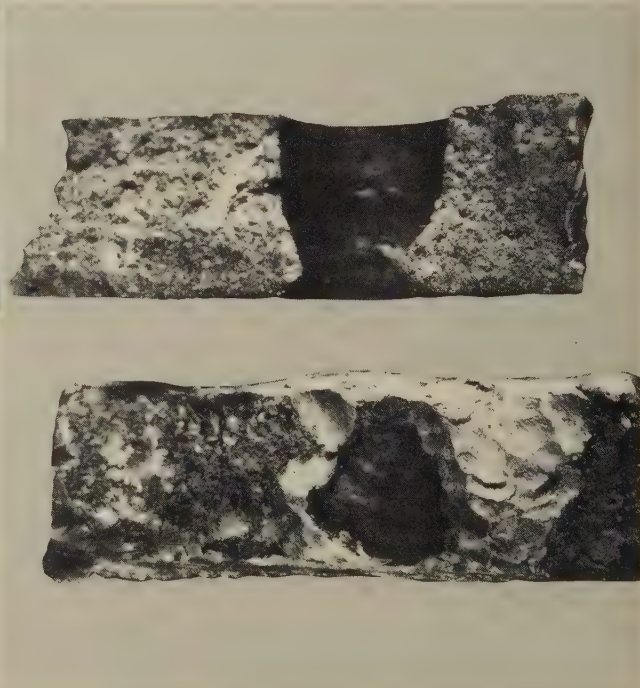
3×

Light fractograph

3979 Views of (at top) fracture surfaces of the upper lug in 3977 and 3978, and (at bottom) the mating surface of the yoke. Yoke surface is greatly deformed by repeated impacts, which obviously occurred after fracture.

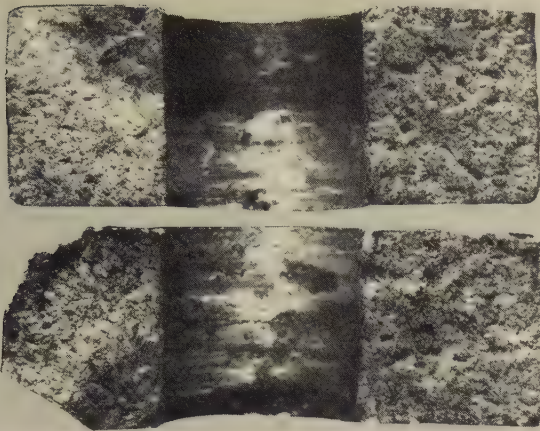
3×

Light fractograph

3980 Views of (at top) fracture surfaces of the lower lug in 3977 and 3978, and of (at bottom) the mating surfaces of the yoke. Note discolored quadrant at top left corner of the bore of the lug (see also 3981), and corresponding area in yoke fracture adjacent to bottom left corner of the bore. Edge of the discoloration is the beach mark of the fatigue crack that was the origin of final fracture.

3981 Enlarged view of one fracture surface of the lug in 3980, more clearly showing the fatigue-crack region at top left corner of the bore. Crack was nucleated at corner marked by arrow at "O". Fatigue area extended approximately to dashed line. See also 3982 and 3983.

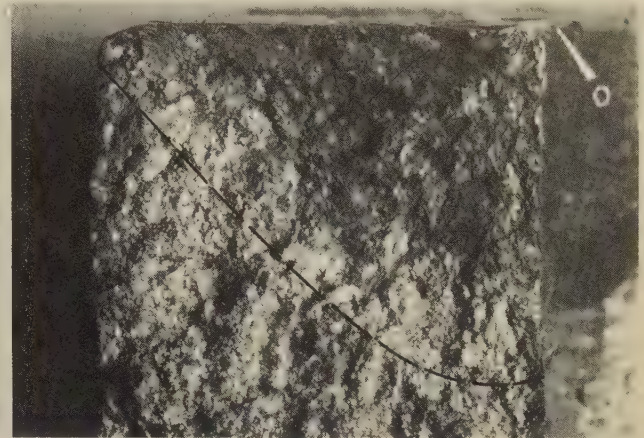
8×

Light fractograph

3982 Two views, at higher magnifications, of the fatigue-crack area of the lug fracture surface in 3981. In the upper view (3982), arrow at "O" denotes the crack nucleus in the chamfer, arrow at "is" points to inboard side, arrow at "hw" indicates hole wall, and arrows at "v" point to voids. The lower view (3983) shows the area near the origin of the crack in 3982 at higher magnification. In general, the crack propagated radially from point "O". See also fractograph 3984 (at right).

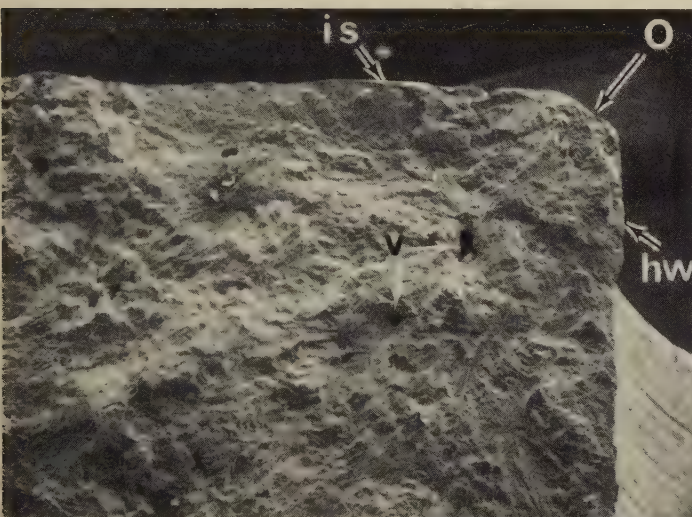
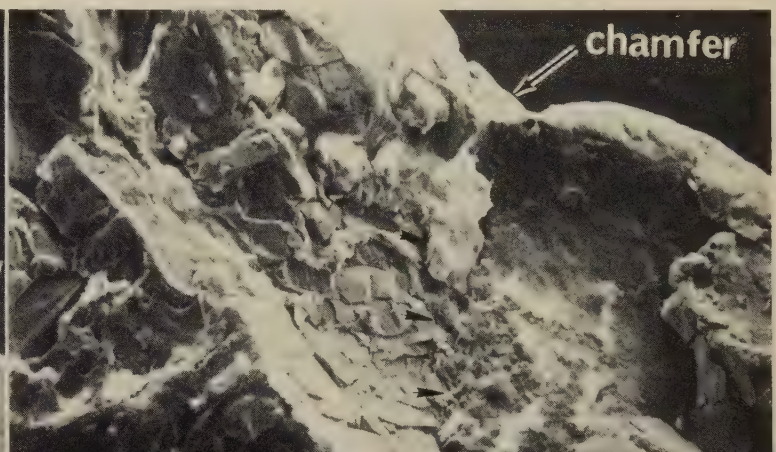
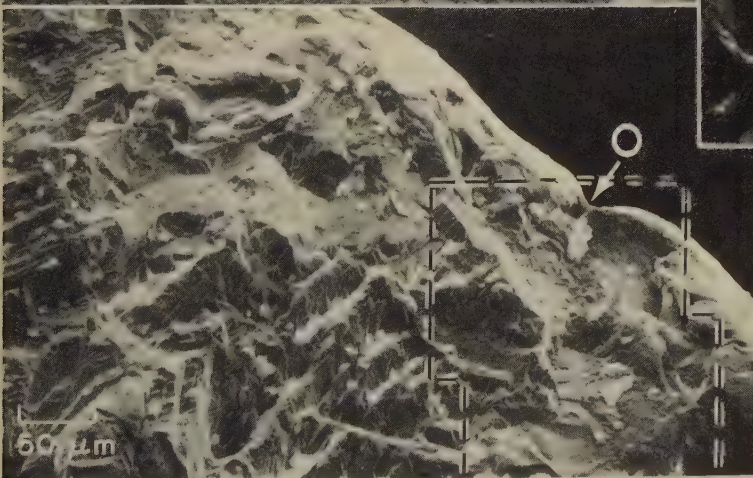
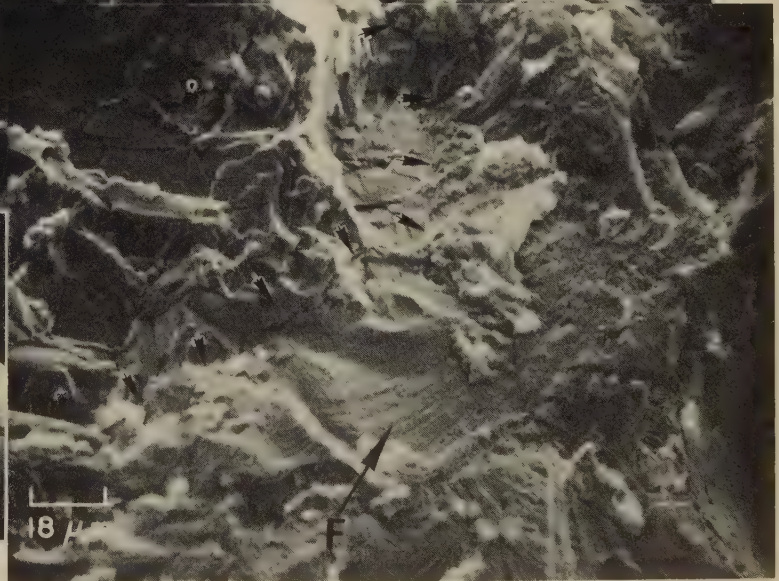
21× (3982); 200× (3983)

SEM fractographs

3984 This is the area within the dashed lines in fractograph 3983 (at lower left), shown at higher magnification. The initial crack opened at the chamfer (upper right corner). The onset of fatigue fracture is indicated by the small arrows running from upper middle to lower left. The arrow at "F" points to an area of typical fatigue striations. The initial phase of fracture was brittle.

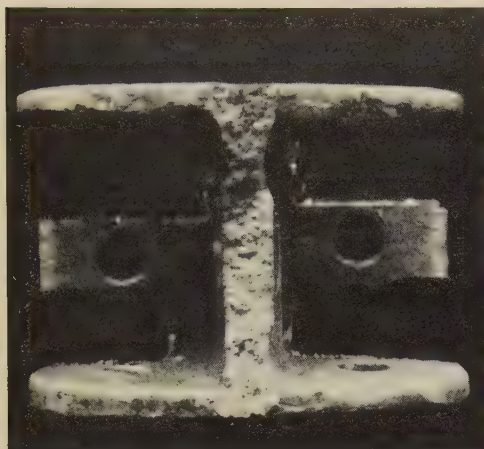
Photograph 1½×

3985 Fractured bell-crank fitting of cast aluminum alloy 356-T6. The fitting, which was from an aircraft rear horizontal elevator, fractured in a crash. No crack origin was found. See also 3986 to 4002.

3986 A more highly magnified view of the fracture in 3985. The appearance here is typical of the entire fracture surface. There is little evidence of surface flow. See also fractograph 3987 (right).

3988 A cellular region that was found to be characteristic of the fracture surface in 3985. Although some features faintly suggest dimples, the higher-magnification view in 3989, showing the area in the rectangle here, reveals no dimples.

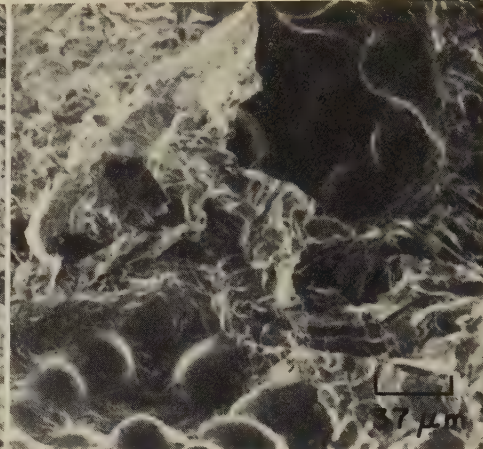
SEM fractograph 270×

3987 Many of the features of the fracture surface in 3986 (left) are associated with shrinkage cavities of the type shown here. The round knobs are exposed secondary arms of dendrites.

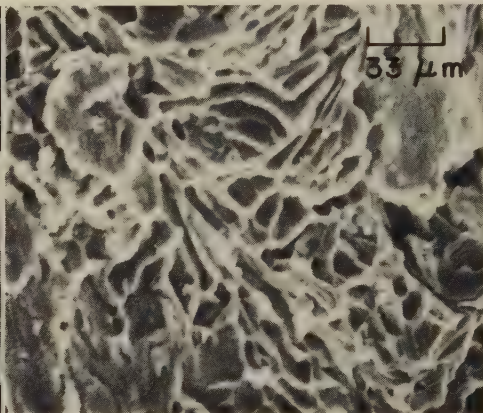
SEM fractograph 1500×

3989 Higher-magnification view of the area outlined by the rectangle in fractograph 3988 (left). There are no suggestions of dimples visible here; instead, the surface exhibits platelets that have been bent and cracked.
